### The Condition of the Aberfeldy Footbridge after 20 Years in Service

# THE CONDITION OF THE ABERFELDY FOOTBRIDGE AFTER 20 YEARS OF SERVICE

Dr Tim Stratford

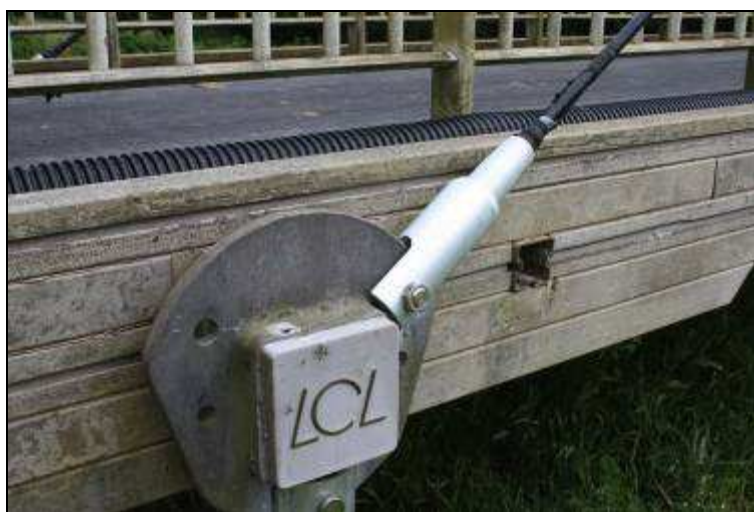
Figure 7. Anchorage of a cable to the bridge deck (June 2008).

The primary structure of the bridge continues to perform well, with no visual signs of overall structural deterioration. Whilst a visual inspection will not detect every deficiency, FRP composites are brittle and hence structural deterioration usually results in cracks in the GFRP components. Careful inspections of the bridge deck have not revealed damage that is a result of structural deficiency, but impact damage has occurred that will be discussed below. The bridge deck has a smooth curve and there is no evidence of movement of the towers, deck, foundations or abutments. There are no slack cables, and there is no sign that the cables have pulled out from their anchorages (Figure 7).

The aramid stay cable ropes incorporate a polyethylene sheath that protects them from moisture ingress and UV corrosion. The cables were over-wrapped where they joined with the aluminium anchorage to ensure protection, but this over-wrap has degraded, potentially leaving a path for moisture ingress into the critical anchorage detail (Figure 7).

These details are relatively straightforward to repair, together with preventative maintenance such as cleaning the deck and replacing the over-wrap layer that protected the connection between the aramid stay cables and the aluminium anchorages. However, the bridge receives minimal maintenance by a non-expert owner. Where repairs have been conducted, they have used traditional techniques such as screwing into the GFRP components, and there is a danger that this could cause long-term damage to the GFRP.

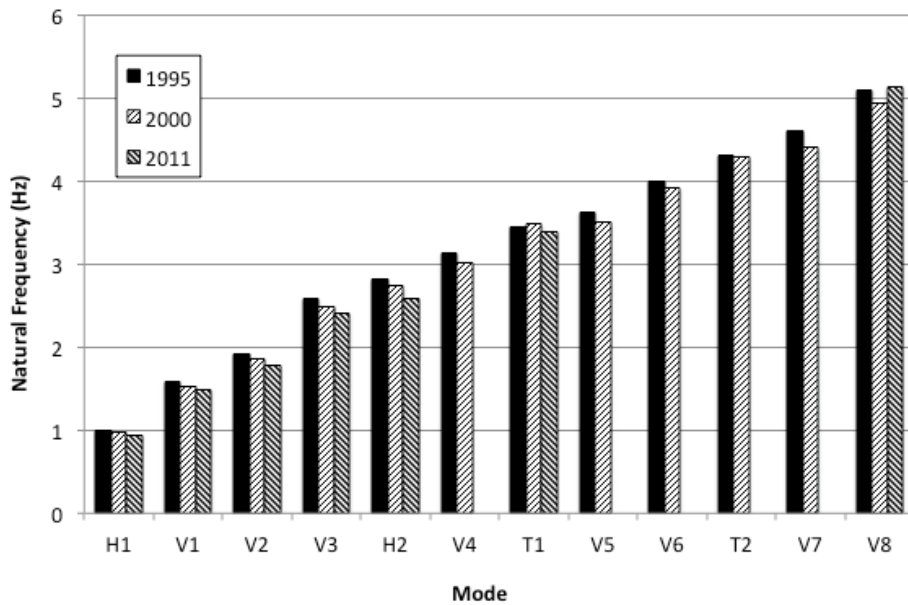
Figure 8. Dynamic response of Aberfeldy Footbridge in 1995, 2000 and 2012.

The reduction in natural frequencies between 1995 and 2000 was previously attributed to the increase in mass of the deck due to the strengthening work (Cadei & Stratford, 2002), but Figure 8 shows a further increase in the natural frequencies between 2000 and 2011. This could be attributed to an increase in mass of the bridge deck due to moisture absorption (GFRP can absorb up to 1.5% moisture by weight), or potentially due to reduction in the stiffness of the GFRP. It must be noted, however, that the 2011 values were obtained in winter, after a period of extended wet weather and cold temperatures. The moisture content of the GFRP will undergo seasonal variations and the bridge stiffness is potentially affected by temperature, consequently the reduction in natural frequencies cannot be taken as a conclusive indicator of structural performance.

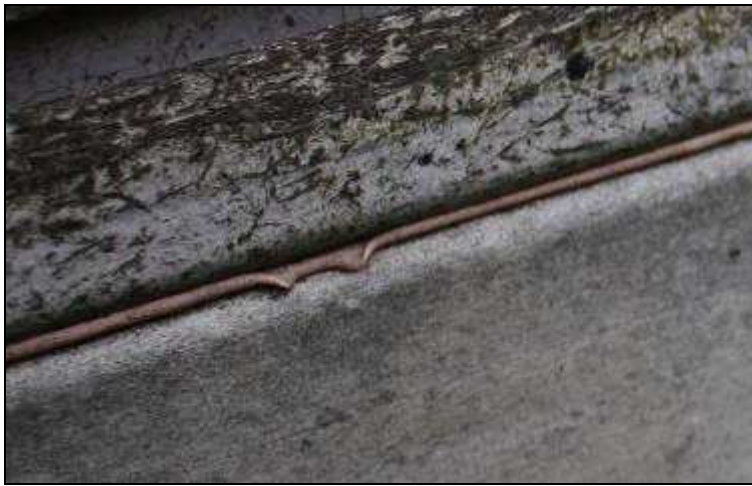
The cut ends of ACCS components were sealed using adhesive to prevent moisture ingress along the fibres, and this seal appears to be in generally good order (Figure 9b). The adhesive joints between the deck components (Figure 9a) also appear to be in good order, with no evidence of the crazing or discoloration that accompanies degradation. There are some small chips in the ACCS components that have left the fibres exposed, but these are very few.

(a) GFRP and adhesive joint condition on bridge deck

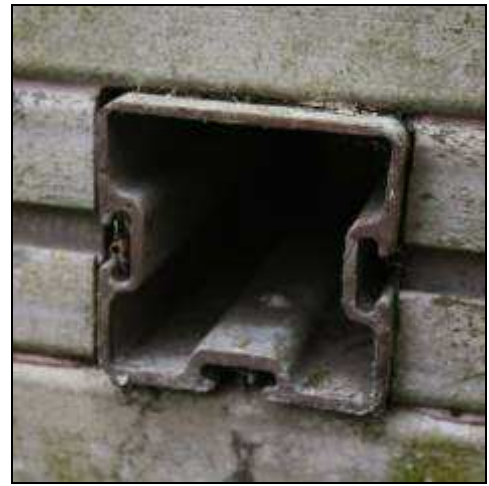
(b) The sealed end of a transverse beam

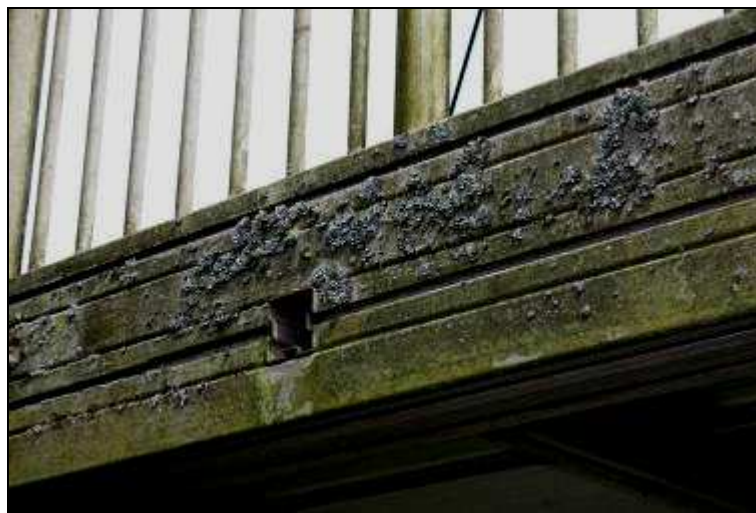
Figure 10. Greening of the bridge deck (June 2008).

The elevations of the bridge are greening-over, due to the growth of moulds, lichens and moss (Figure 10). The grooves and connections on the side of deck trap water supplies for growth. The growth is no more than would be expected on a timber bridge. Provided that it is a surface growth, this greening of the bridge will not affect the structural performance of the bridge, but it could exacerbate degradation where the surface veil of the components has occurred. There is very little growth where over the carbon strengthening around the primary transverse beams (Figure 6), due to fewer indentations that trap water, and due to the use of a resin that inhibits growth.

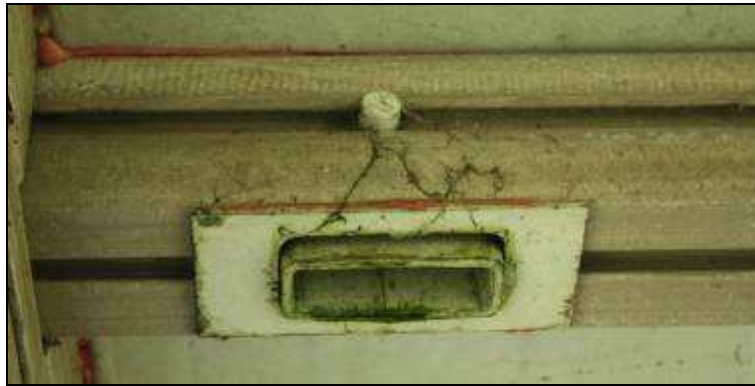
Figure 11. Connection of the parapet post beneath the bridge deck (June 2008).

The parapet posts pass through the deck, and were doweled beneath the deck (Figure 11) and bonded to the top of the deck. The top and bottom rails are connected to the parapet posts by means of a sleeved plate that passes through the post (Figure 12). This arrangement was designed to accommodate movement

of the parapets as the bridge flexes; the sleeved plate was intended to provide damping through friction and hence improve the dynamic response of the bridge. The post-to-deck and rail-to-post connections have all worked loose, and there is considerable movement of the parapet components as the bridge flexes, but very little friction. Some top rail connections have become completely detached (Figure 12), and rudimentary repairs have been effected using screws and zip ties (Figure 13).

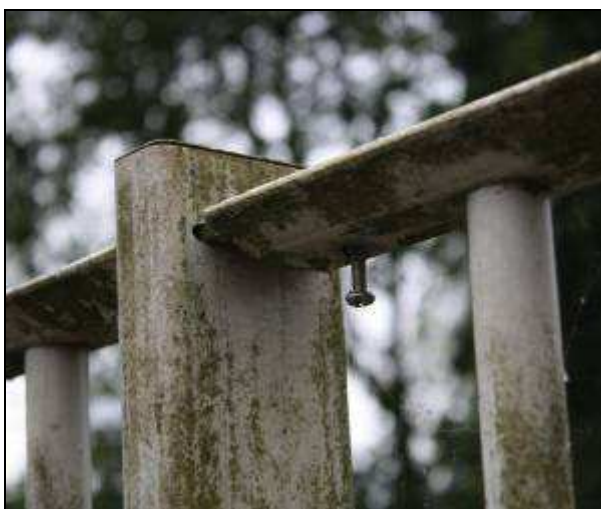
(a) Screw repair (June 2008)

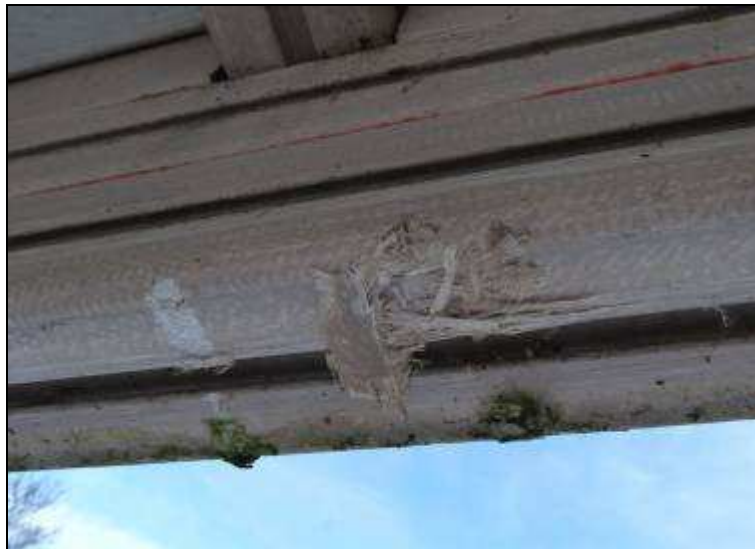
Figure 15. Impact damage to the underside of the deck (December 2010).

Another example of impact damage to the underside of the deck is shown in Figure 15, while Figure 16 shows that an aluminium angle has been added to protect (or possibly repair) the underside of the deck adjacent to the south tower. Fixing this angle using screws is not ideal, as it is likely to result in splitting between the glass fibres, resulting in accelerated degradation of the GFRP.

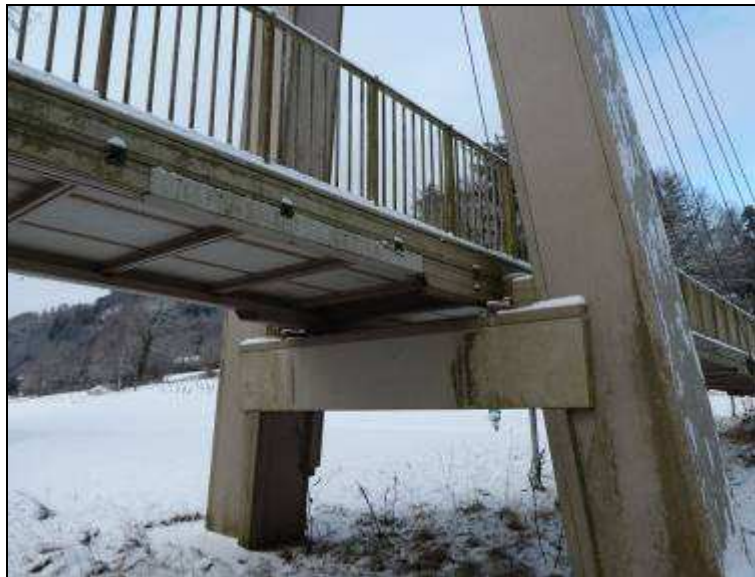
Figure 16. Impact protection applied beneath the deck (December 2010).

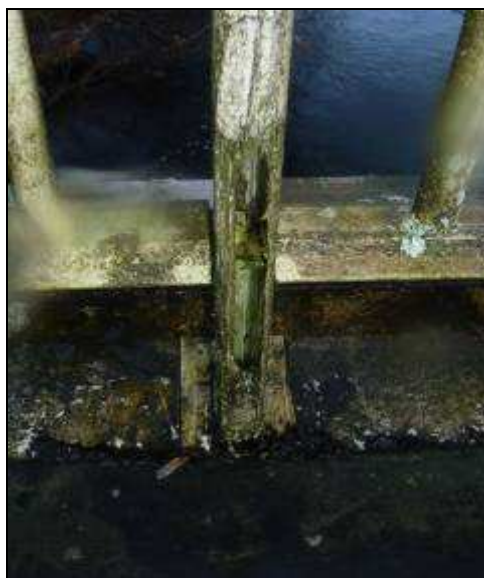
In 2002, the base of the parapet posts were noted to be 'badly scuffed' (Cadei & Stratford, 2002). Figure 17 shows how after another ten years service, the base of some posts are now severely damaged, with substantial loss of section due to impact and abrasion. These posts require repair, and should be protected using a kick board. Separate impact protection has also been added to the northern end of the parapets (Figure 2).

Figure 17. Impact damage to the bottom of a parapet post (December 2011).
